**Environmental and Social Incident
Impact Assessment Report for the
Tailings Dam Failure at Sino-Metals
Leach Zambia Limited**

18th December 2025

**Environmental and Social Incident Impact Assessment and
Recommendations for Remediation and Restoration measures
regarding the Tailings Dam failure incident at Sino-Metals Leach
Zambia Limited in Kalulushi District that led to the discharge of
acidic leach residue into the surrounding open environment, the
Chambishi Stream, Mwambashi and Kafue Rivers**

RFP- ZEMA/RFP/CS/21/08/2025

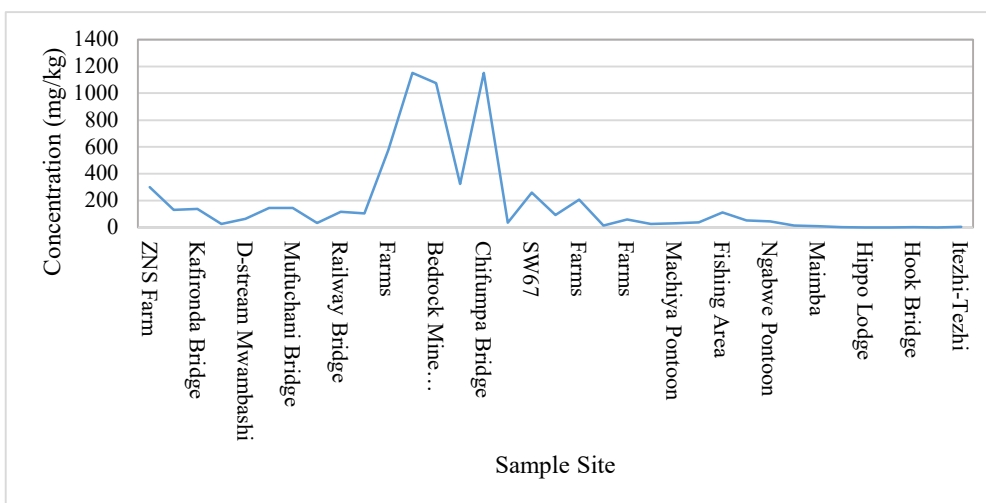
Figure 4-40 showing the concentration of Cobalt in sediment

The figure illustrates the variation of cobalt (Co) in Kafue River sediments. Significant elevation is observed between the Kitwe-Ndola Road Bridge and Kafulafuta, with a maximum value of 1,152 mg/kg, followed by a gradual decline from 259 mg/kg to below 10 mg/kg.

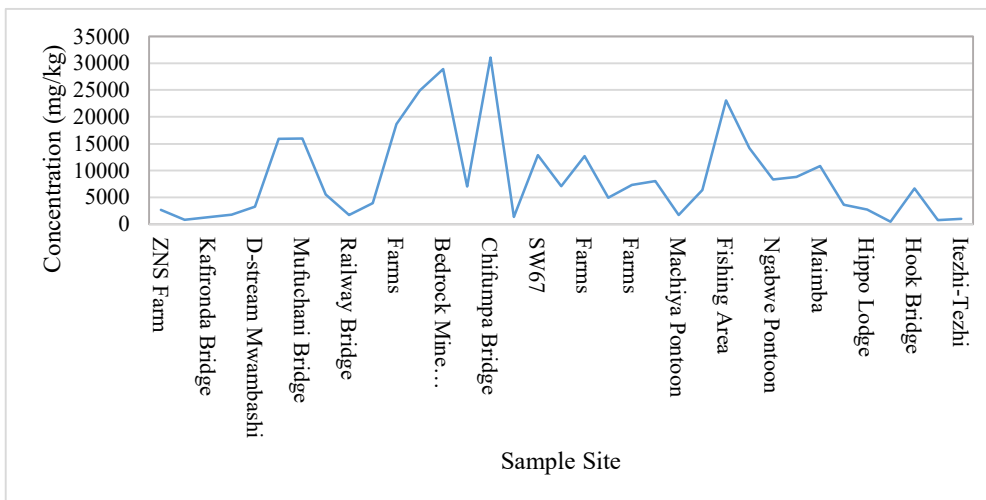
Figure 4-43: Graph showing the concentration of sulphates in sediment

Figure 4-43 illustrates the variation of sulphate in Kafue River sediments. Following fluctuations after ZNS Farm, it reached a peak of 31,087 mg/kg at Chifumpa Bridge, then declined significantly. A subsequent rise was observed at the Fishing Area, after which it stabilized with downward fluctuations.

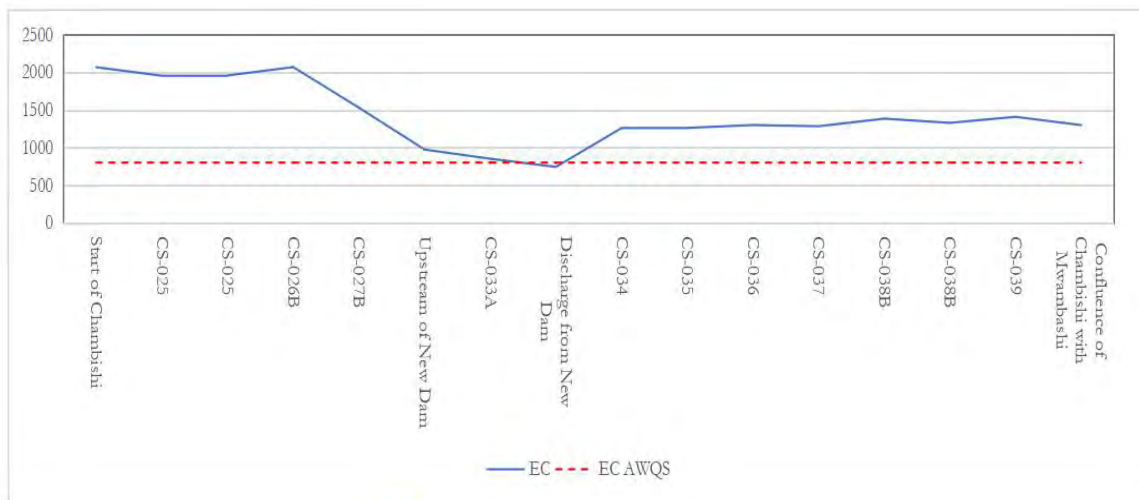
Figure 4-45: Electrical conductivity along Chambishi Stream

Figure 4-45 shows the profile of electrical conductivity along Chambishi Stream. The graph shows that the electrical conductivity of Chambishi Stream was mostly above the recommended value of Ambient Water Quality Standards (AWQS) of 800 $\mu\text{S}/\text{cm}$. The EC decreased from 2,070 $\mu\text{S}/\text{cm}$ upstream of New Dam to 744 $\mu\text{S}/\text{cm}$ at the discharge point. The decrease in the electrical conductivity is attributed to the uptake or settling of dissolved solids out of solution by the wetland. The graph also shows that electrical conductivity increased to 1,260 $\mu\text{S}/\text{cm}$ upon leaving New Dam.

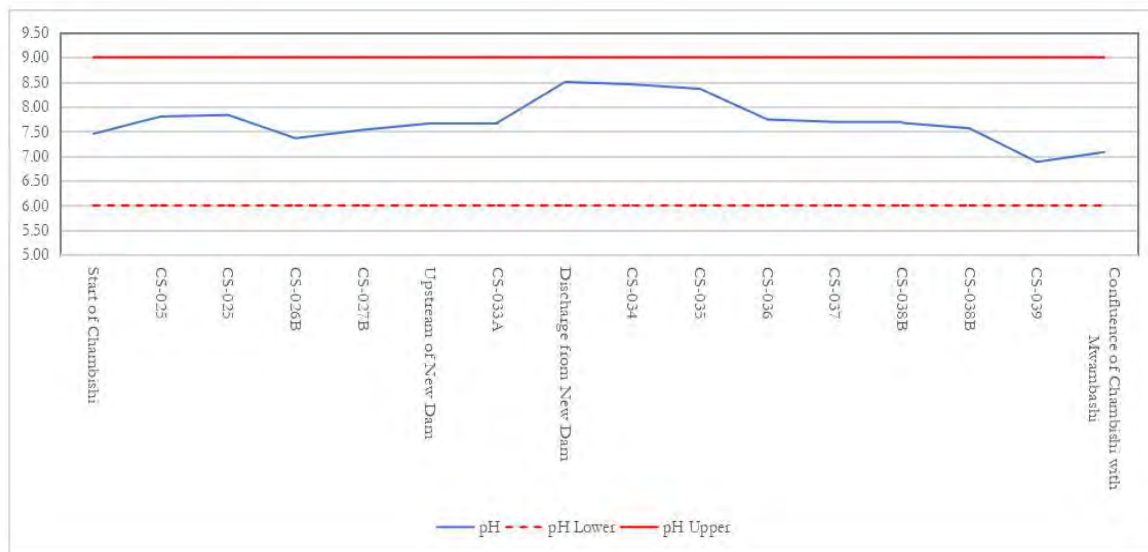
Figure 4-46: pH of water along Chambishi Stream

Figure 4-46 shows the pH profile of water along Chambishi Stream. The Figure shows the pH was within the recommended value of 6.0 to 9.0. The pH increased from 7.68 before New Dam to 8.5 at the discharge from New Dam. The increase in the pH of water has been attributed to the dosing of water coming out of New Dam with sodium Hydroxide (NaOH) by Sino-Metals. Dosing is carried out for the purpose of raising the pH of the water and precipitating the metal ions out of solution. The graph shows that the pH of Chambishi Stream returns to its pre-dosing level before the confluence with Mwambashi River.

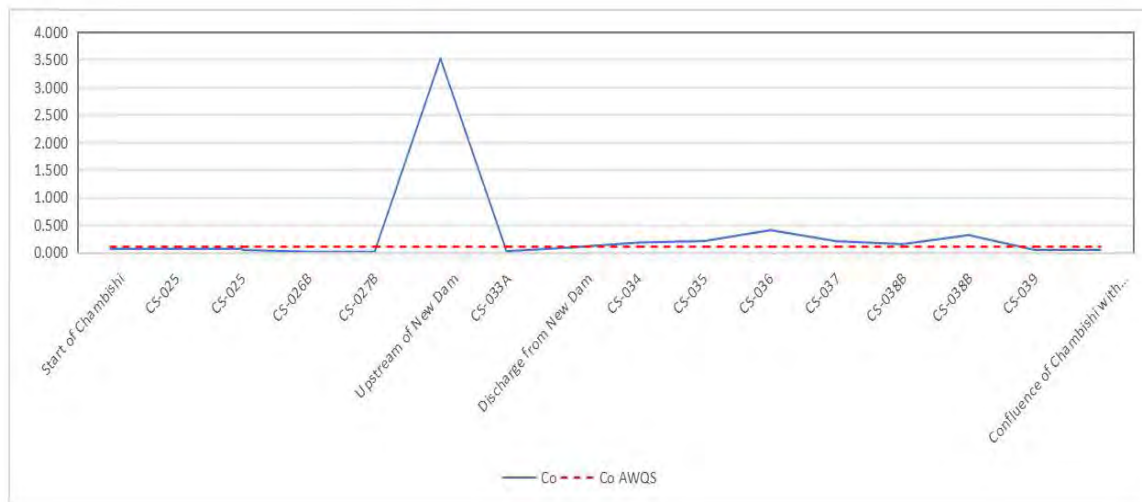
Figure 4-48: Concentration of cobalt in Chambishi Stream

The concentration of cobalt in the Chambishi Stream is shown in Figure 4-48. The graph shows that the concentration of cobalt is below the recommended value of 0.1 mg/L before entering the New Dam. It peaks at 3.512 mg/L at the New Dam, after leaving the New Dam, the concentration decreased significantly and fluctuated around the recommended value. It dropped notably below the recommended value before converging into the Mwambashi River.

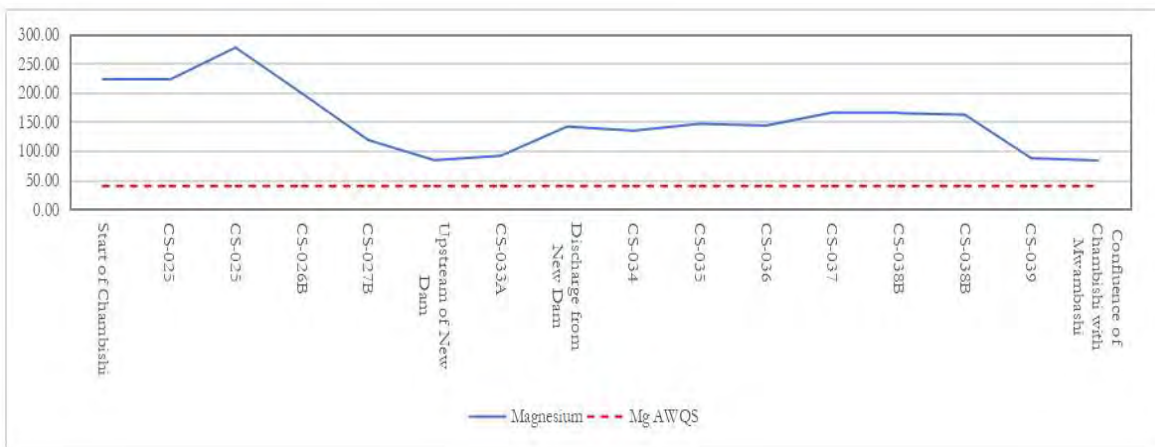
Figure 4-51: Concentration of magnesium in Chambishi Stream

The concentration of magnesium in the Chambishi Stream is shown in Figure 4-51. The graph shows that the magnesium concentration in the water consistently exceeds the recommended value of 40 mg/L under the Ambient Water Quality Standards (AWQS). The magnesium concentration decreases significantly after entering the wetland, dropping from 277.21 mg/L at the discharge of Weners Dam to 91.80 mg/L at the discharge of the New Dam.

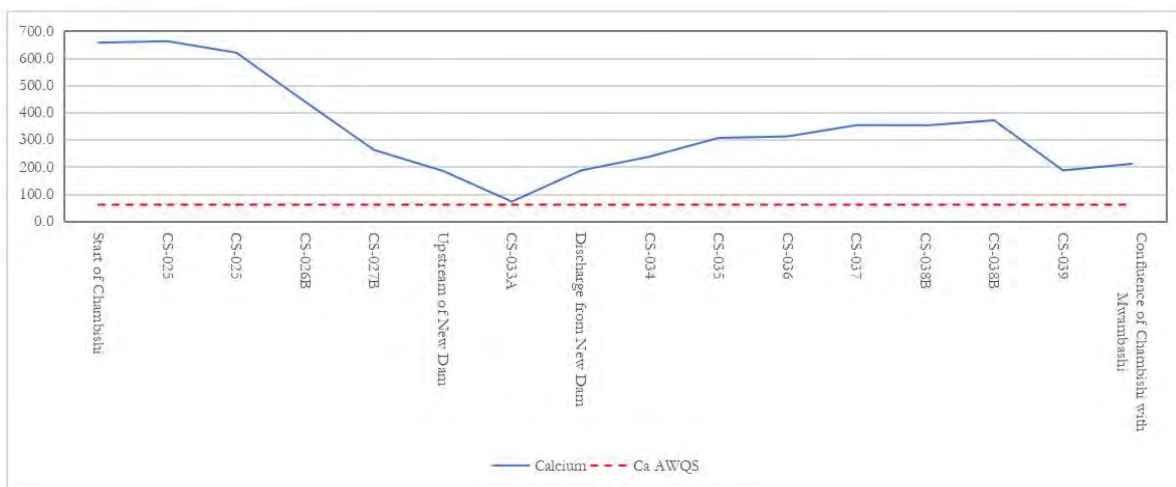
Figure 4-52: Concentration of calcium in Chambishi Stream

The concentration of calcium in the Chambishi Stream is shown in Figure 4-52. The graph shows that the calcium concentration in the water consistently exceeds the recommended value of 60 mg/L. The concentration decreased significantly after entering the wetland, dropping from 662 mg/L at the discharge of Weners Dam to 71.5 mg/L at the discharge of the New Dam.

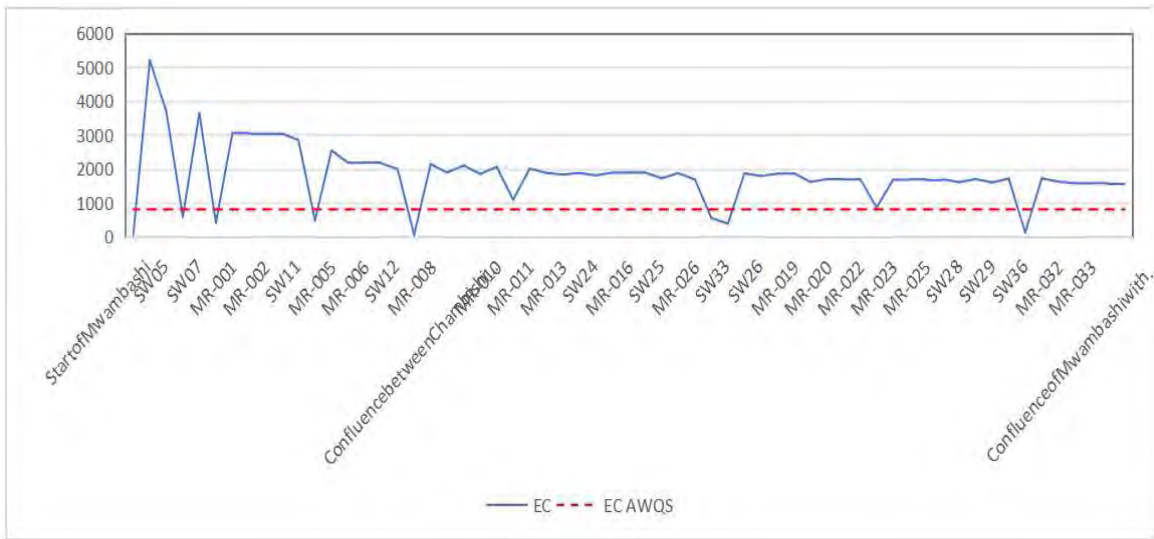
Figure 4-53: Electrical conductivity along Mwambashi River

Figure 4-53 shows the profile of electrical conductivity along Mwambashi River. The average value of EC in the Mwambashi River was 1809 $\mu\text{S}/\text{cm}$, mostly above the Ambient Water Quality Standards (AWQS) of 800 $\mu\text{S}/\text{cm}$. The EC was at a low of 46 $\mu\text{S}/\text{cm}$ upstream, near the source. But increased to 5200 $\mu\text{S}/\text{cm}$ after the confluence with Mutimpa Stream and gradually decreased to 1567 $\mu\text{S}/\text{cm}$. The maximum value was found 30 km upstream of the confluence of the Chambishi Stream and Mwambashi Rivers. The graph shows that the electrical conductivity was no significant change at the confluence of Chambishi with Mwambashi.

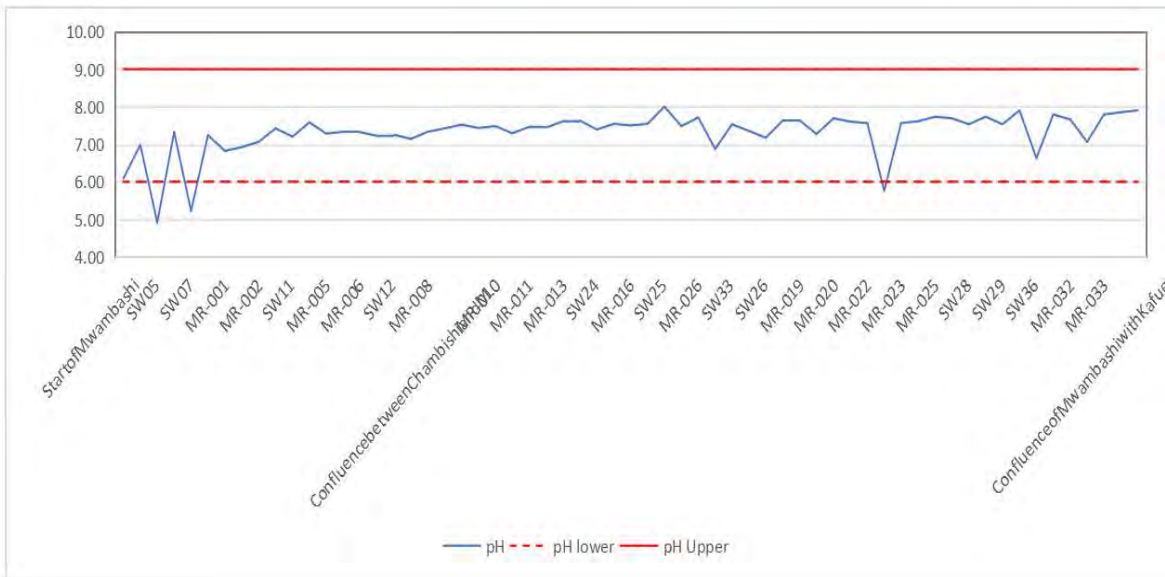
Figure 4-54: pH of water along Mwambashi River

Figure 4-54 presents the pH profile along the Mwambashi River, with an average pH of 7.35. The majority of the river's pH levels fall within the Ambient Water Quality Standards (AWQS) range of 6-9, though the upper reaches generally show lower values. The graph shows a gradual increase in pH after the confluence of Chambishi with Mwambashi River, with occasional drops caused by the lower pH of the merging tributaries. The lowest pH on Mwambashi River of 4.91 was recorded after the confluence with Mutimpa Stream, upstream of Chambishi Stream.

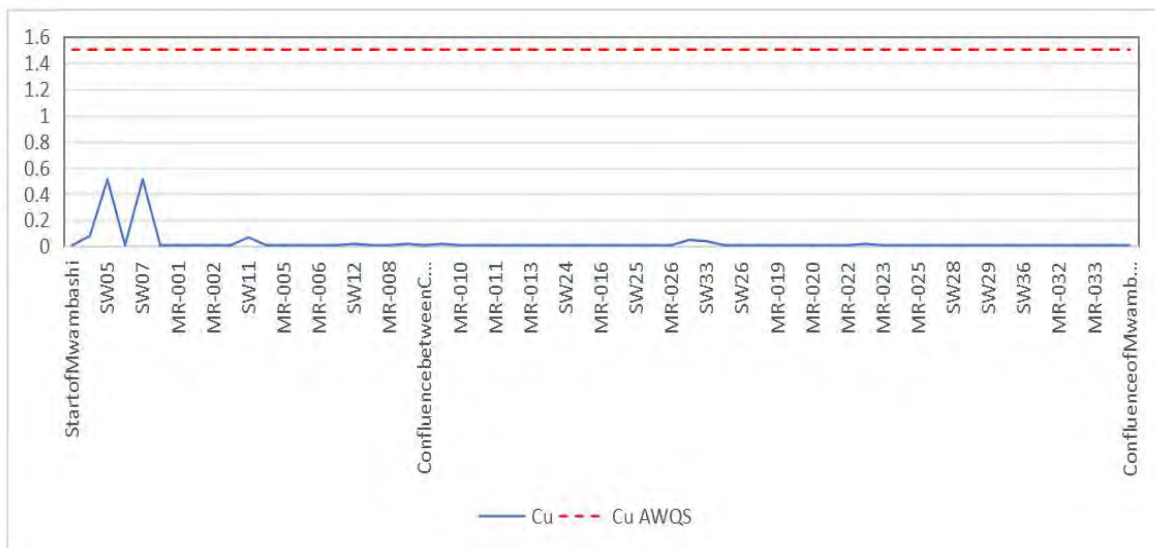
Figure 4-55: Concentration of Copper in Mwambashi River

Figure 4-55 shows the profile of Copper along Mwambashi River. With the exception of the upstream area where the maximum concentration reached 0.51 mg/L, the maximum value was found 30 km upstream of the confluence of the Chambishi Stream and Mwambashi Rivers. The average concentration at other locations was 0.014 mg/L, significantly below the Ambient Water Quality Standards (AWQS) recommended value of 1.5 mg/L. Copper was no significant change at the confluence of Chambishi with Mwambashi.

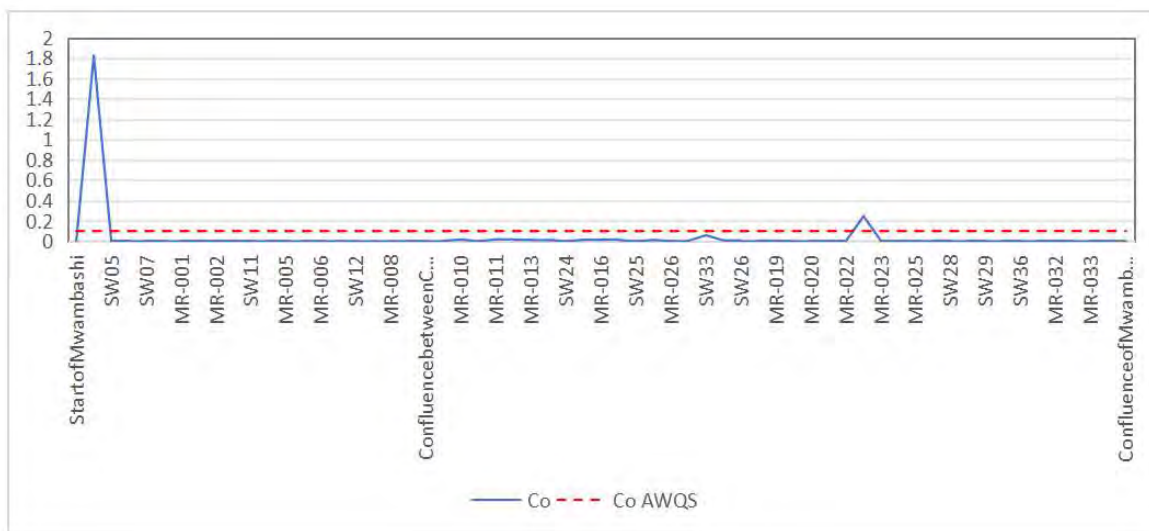
Figure 4-56: Concentration of Cobalt in Mwambashi River

Figure 4-56 shows the profile of Cobalt along Mwambashi River. With the exception of the upstream area where the maximum concentration reached 1.8 mg/L, the maximum value was found 30 km upstream of the confluence of the Chambishi Stream and Mwambashi Rivers. The average concentration at other locations was 0.0098 mg/L, significantly below the Ambient Water Quality Standards (AWQS) of 0.1 mg/L. Cobalt was no significant change at the confluence of Chambishi with Mwambashi.

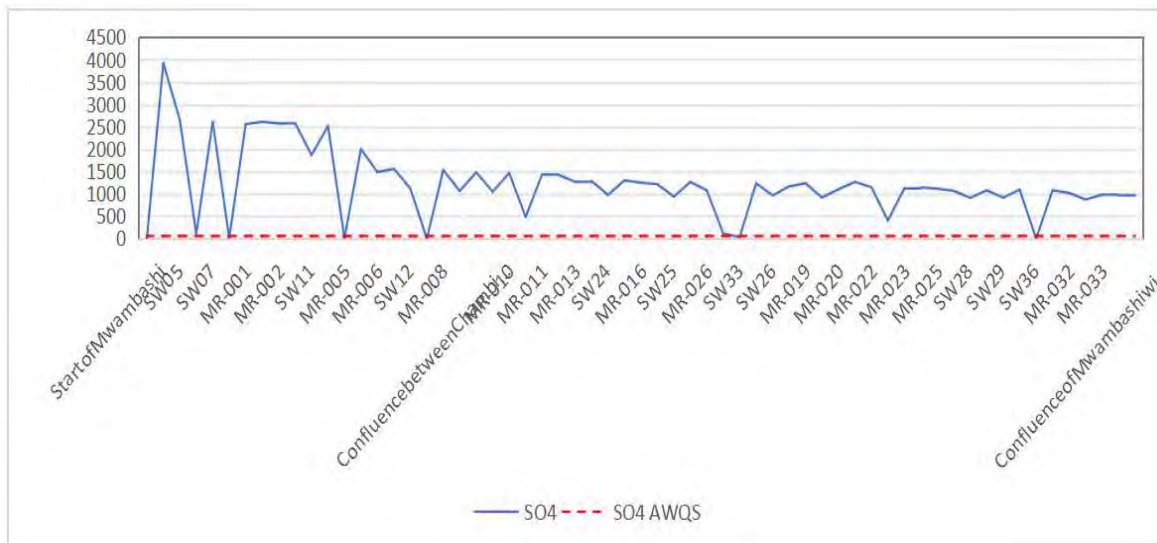
Figure 4-58: Concentration of sulphates in Mwambashi River

Figure 4-58 shows the profile of sulphates along Mwambashi River. The average value of sulphates in the Mwambashi River was 1,225 mg/L, significantly exceeding the Ambient Water Quality Standards (AWQS) recommended value of 60 mg/L. With the exception of the upstream area where the maximum concentration reached 3,920 mg/L, the maximum value was found 30 km upstream of the confluence of the Chambishi Stream and Mwambashi Rivers. Sulphates was no significant change at the confluence of Chambishi with Mwambashi.

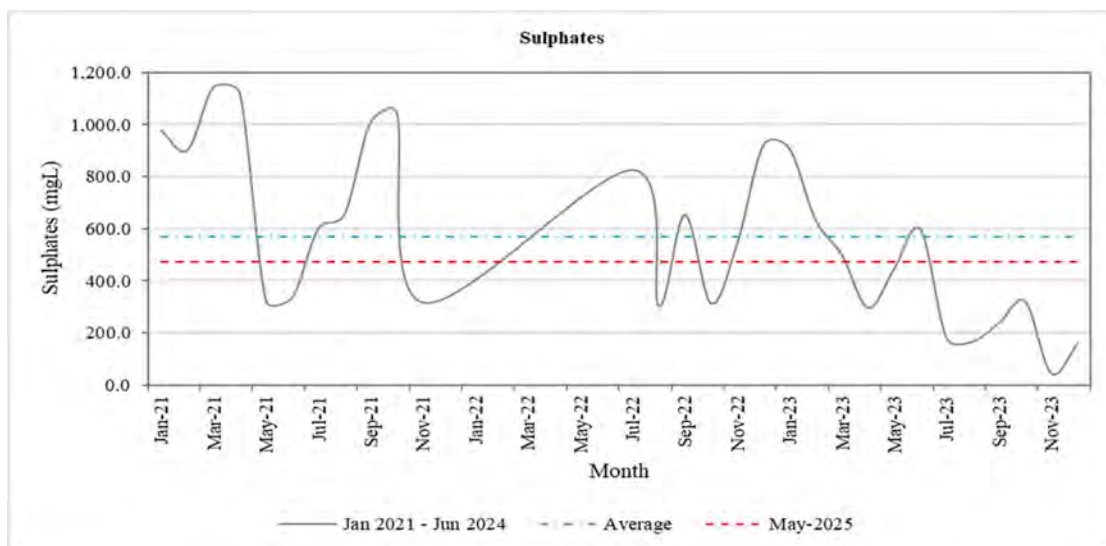
Figure 4-72: Graph of sulphates of discharged from New Dam into Chambishi Stream from Jan 2021 to Jun 2024 and Oct 2025

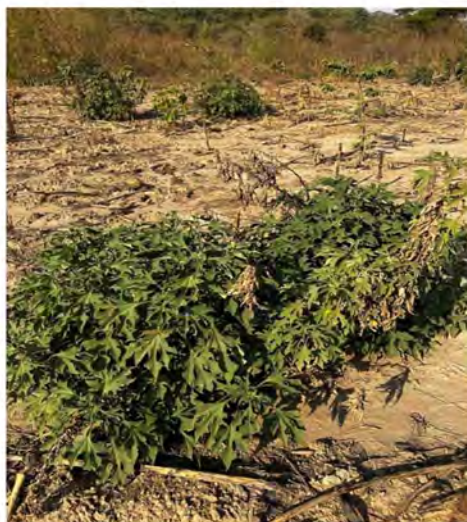
a) Tithonia thriving in a farmer's field where the tailings liquor passed- Kalulushi
